IMCA Safety Flash 03/13

January 2013

I Fatality during Basket Transfer

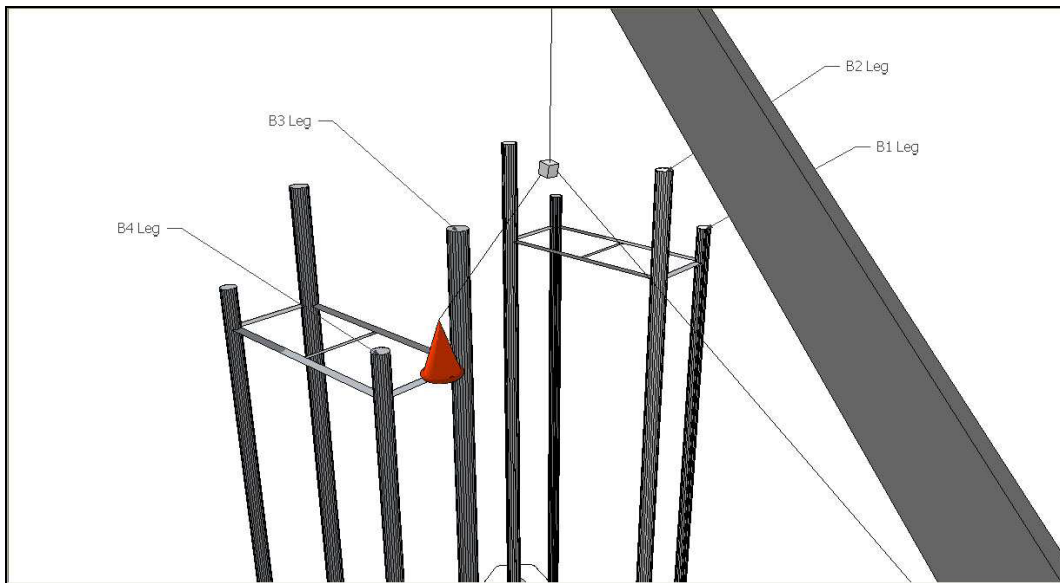
- ◆ There was no provision of an adequate landing platform for the personnel basket;
- ◆ The basket landing area being used was on a walkway grating 1.2 m in width and between two transition pieces of the jacket;
- ◆ During the lifting operation of the basket the crane barge was rolling and pitching between 1–2 degrees and the boom angle of the crane was at 31 degrees (main crane in use), a combination of factors which allowed the basket to swing when raised;
- ◆ The crane operator continued to lift the basket despite it striking the transition pieces of the jacket;
- ◆ The two tag lines attached to the basket were not used to stabilise the basket whilst it was being hoisted.

Basket landed between B3 and B4 transition piece to pick up two persons

- ◆ Review the type of basket currently in use and consider an alternative which can provide impact and fall protection;
- ◆ Identify and provide a proper landing platform for personnel basket landing in the initial jacket positioning phase;
- ◆ Reinforce standard operating procedure with regards to personnel basket transfer and lifting operations;
- ◆ Reinforce the stop work policy. All personnel have the right to refuse to be transferred or conduct a transfer when they consider the situation unsafe to do so;
- ◆ Reinforce the safety awareness of personnel basket transfer by conducting more safety discussions on the subject. Personnel working on barges which use personnel basket transfer method have been reminded about the safety issues, to be more vigilant and exercise their right to stop the work if they see the conditions are unsafe to continue.

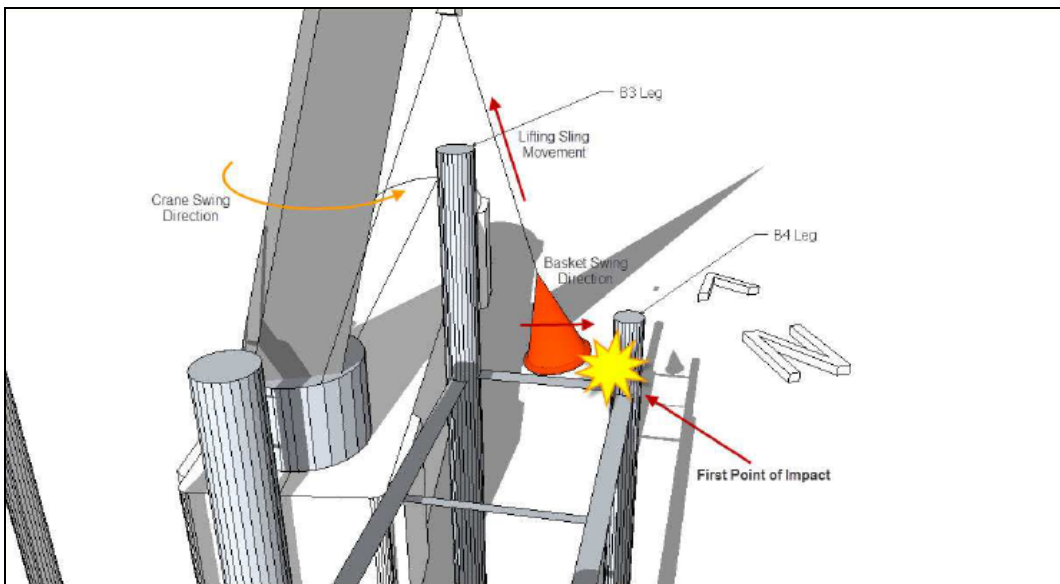
Basket begins to swing when lifted

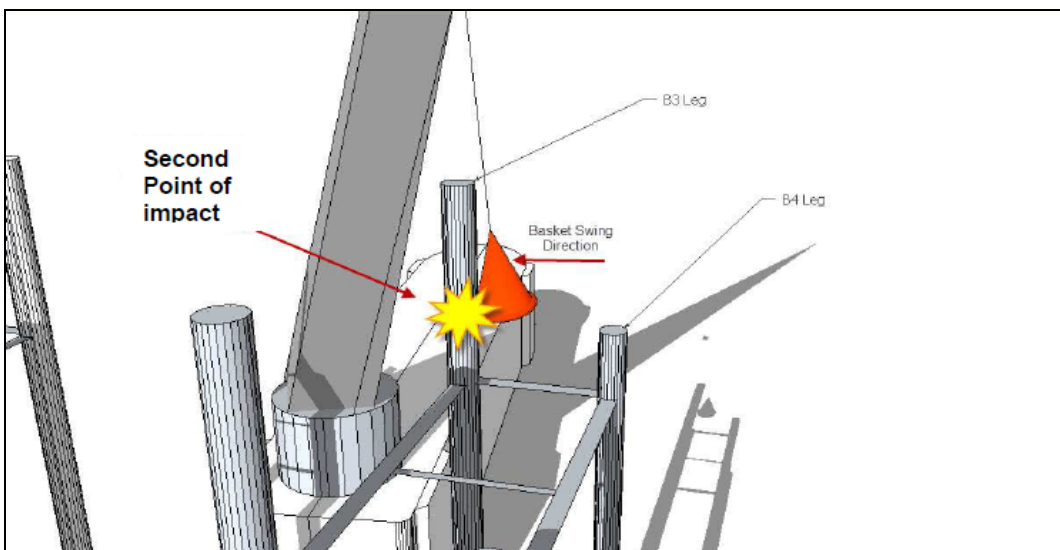
Basket strikes platform transition

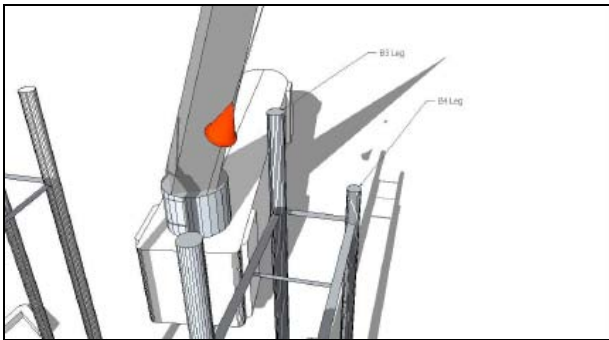
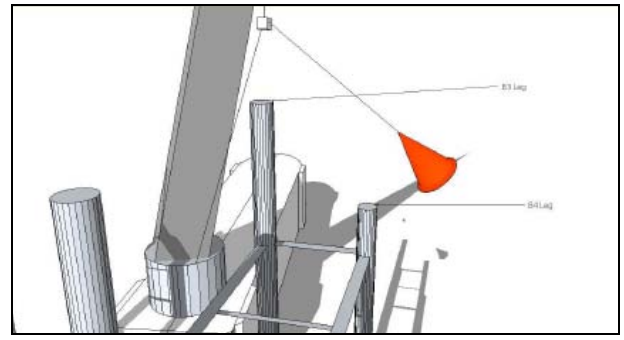
Basket continues to swing with both personnel on board

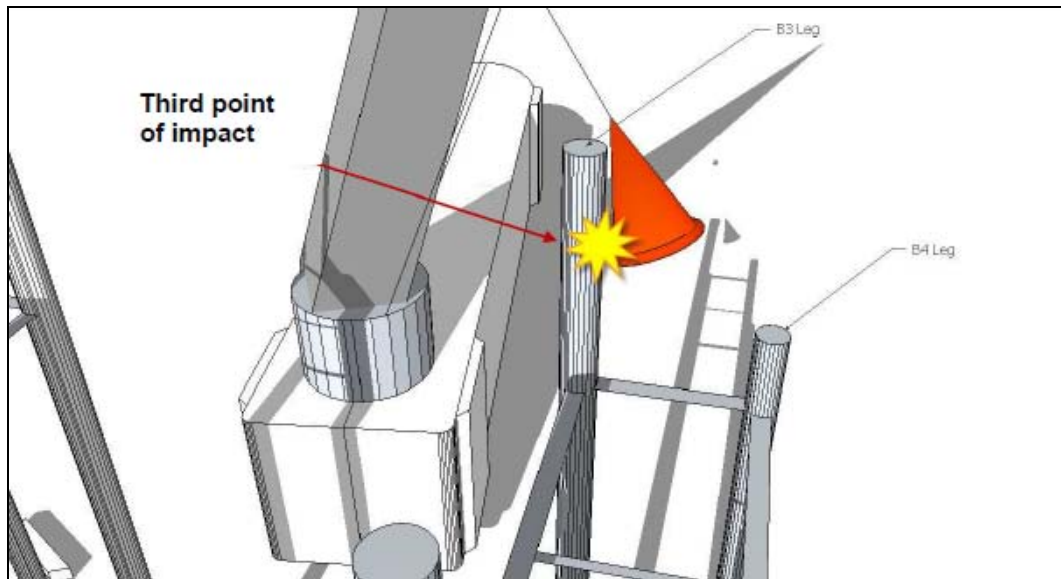
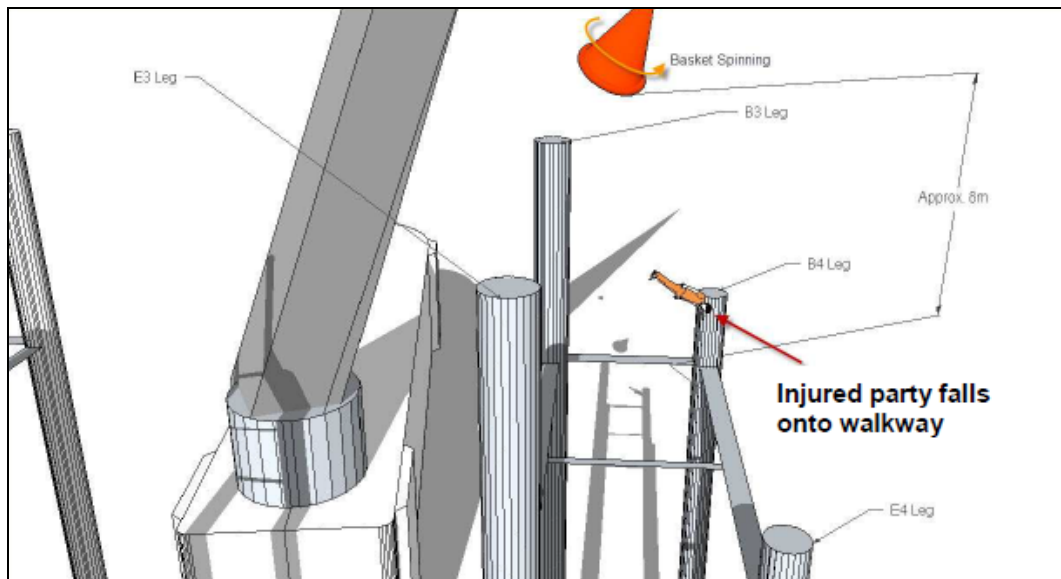
Basket continues to be raised whilst swinging and spinning, at this point one person loses his grip and falls from basket (approx. 8m), landing on walkway between B4 and E4 legs

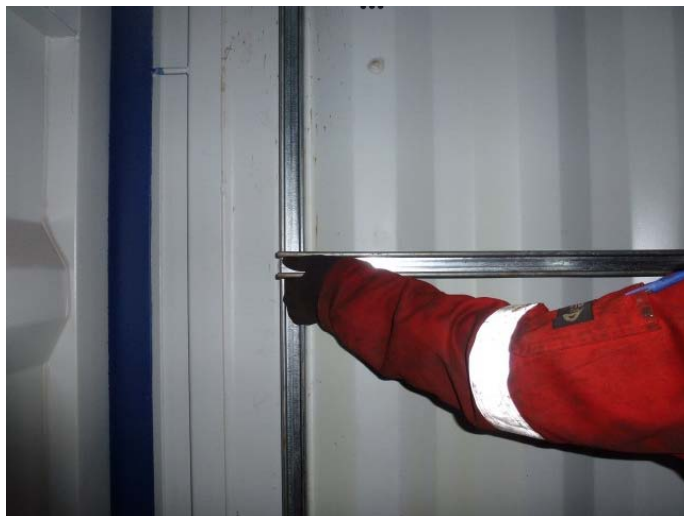
Showing Unistrut and demonstrating how a thumb could become trapped within it

- ◆ Risk assessments and toolbox talks were all in place prior to the incident;
- ◆ All crew attended the pre-work briefing and toolbox talk;
- ◆ Full appropriate personal protective equipment (PPE) was being worn, including suitable gloves;
- ◆ The injured person did not feel 'under pressure' to get the task done too quickly;
- ◆ The incident occurred near the end of the task;
- ◆ There was insufficient appreciation of potential risks if a section of Unistrut detached unexpectedly. Had this potential been correctly identified it is unlikely that the incident would have happened; the risk assessment was not adequate.

The primary action was to ensure that, henceforth, two people should be involved in the installation and/or removal of Unistrut sections, regardless of length. The second person should provide support to the Unistrut whilst it is being secured in position or removed to prevent any unexpected movement.

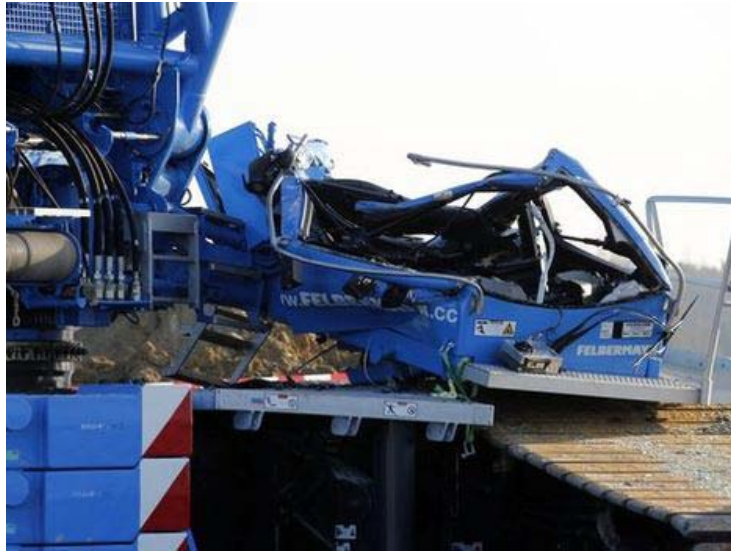
A fatal wind farm incident has been brought to the attention of IMCA. A crane operator working at an onshore wind farm site in Europe was killed when a blade dropped onto the cab during the installation of a turbine.

Crane cab destroyed by turbine blade landing on top of it
